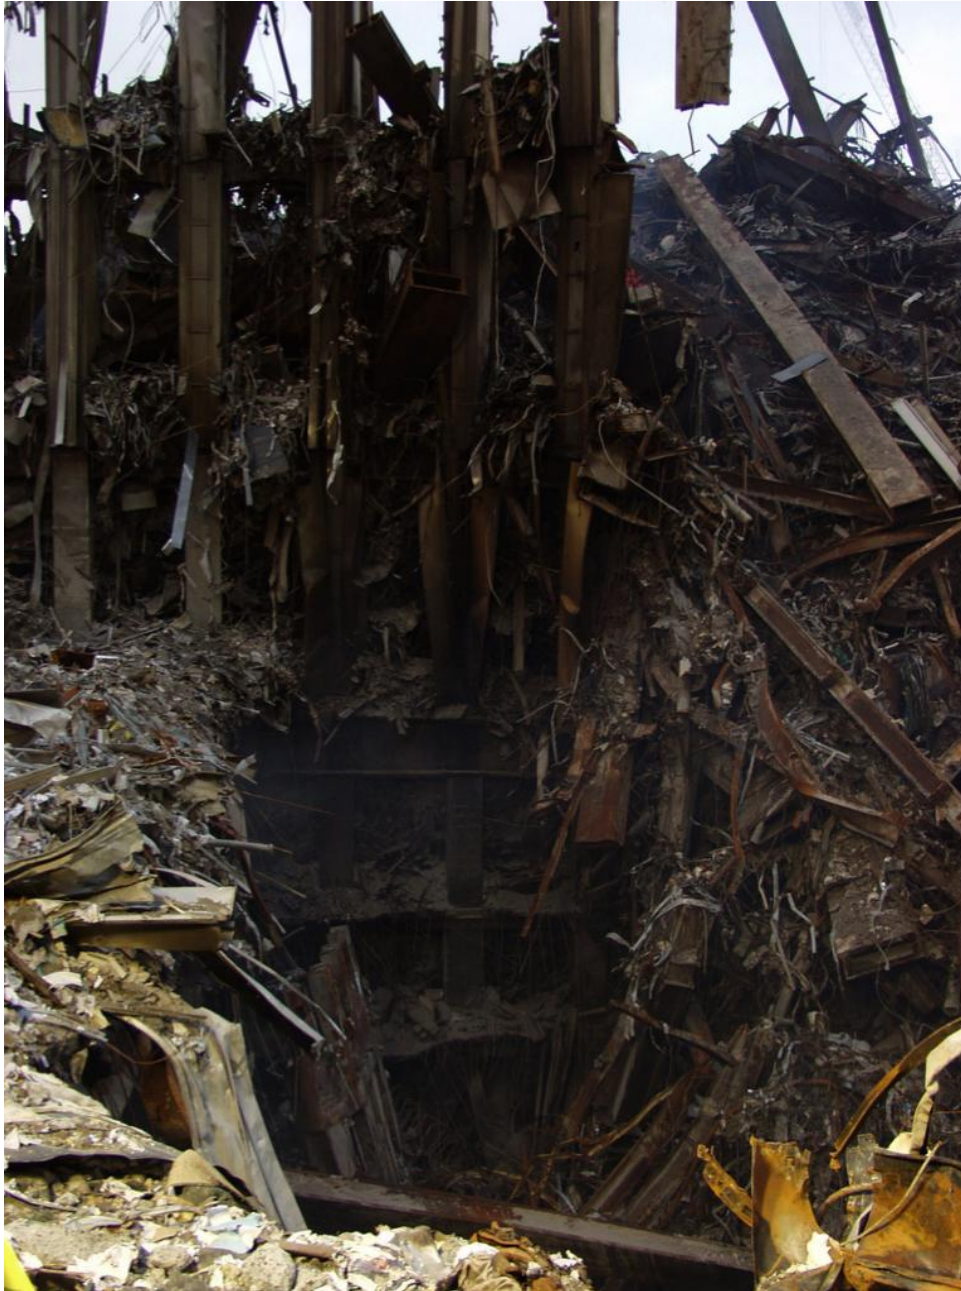
Figure 18. This hole adjacent to WTC2 (zone 2 in Figure 303(c)) is through sidewalk and pavement. This hole contains more debris than the hole discussed in Figure 300 above. It looks as if the debris fell in the hole. Note the scale, shown above. *(photo filed 9/21/01)*

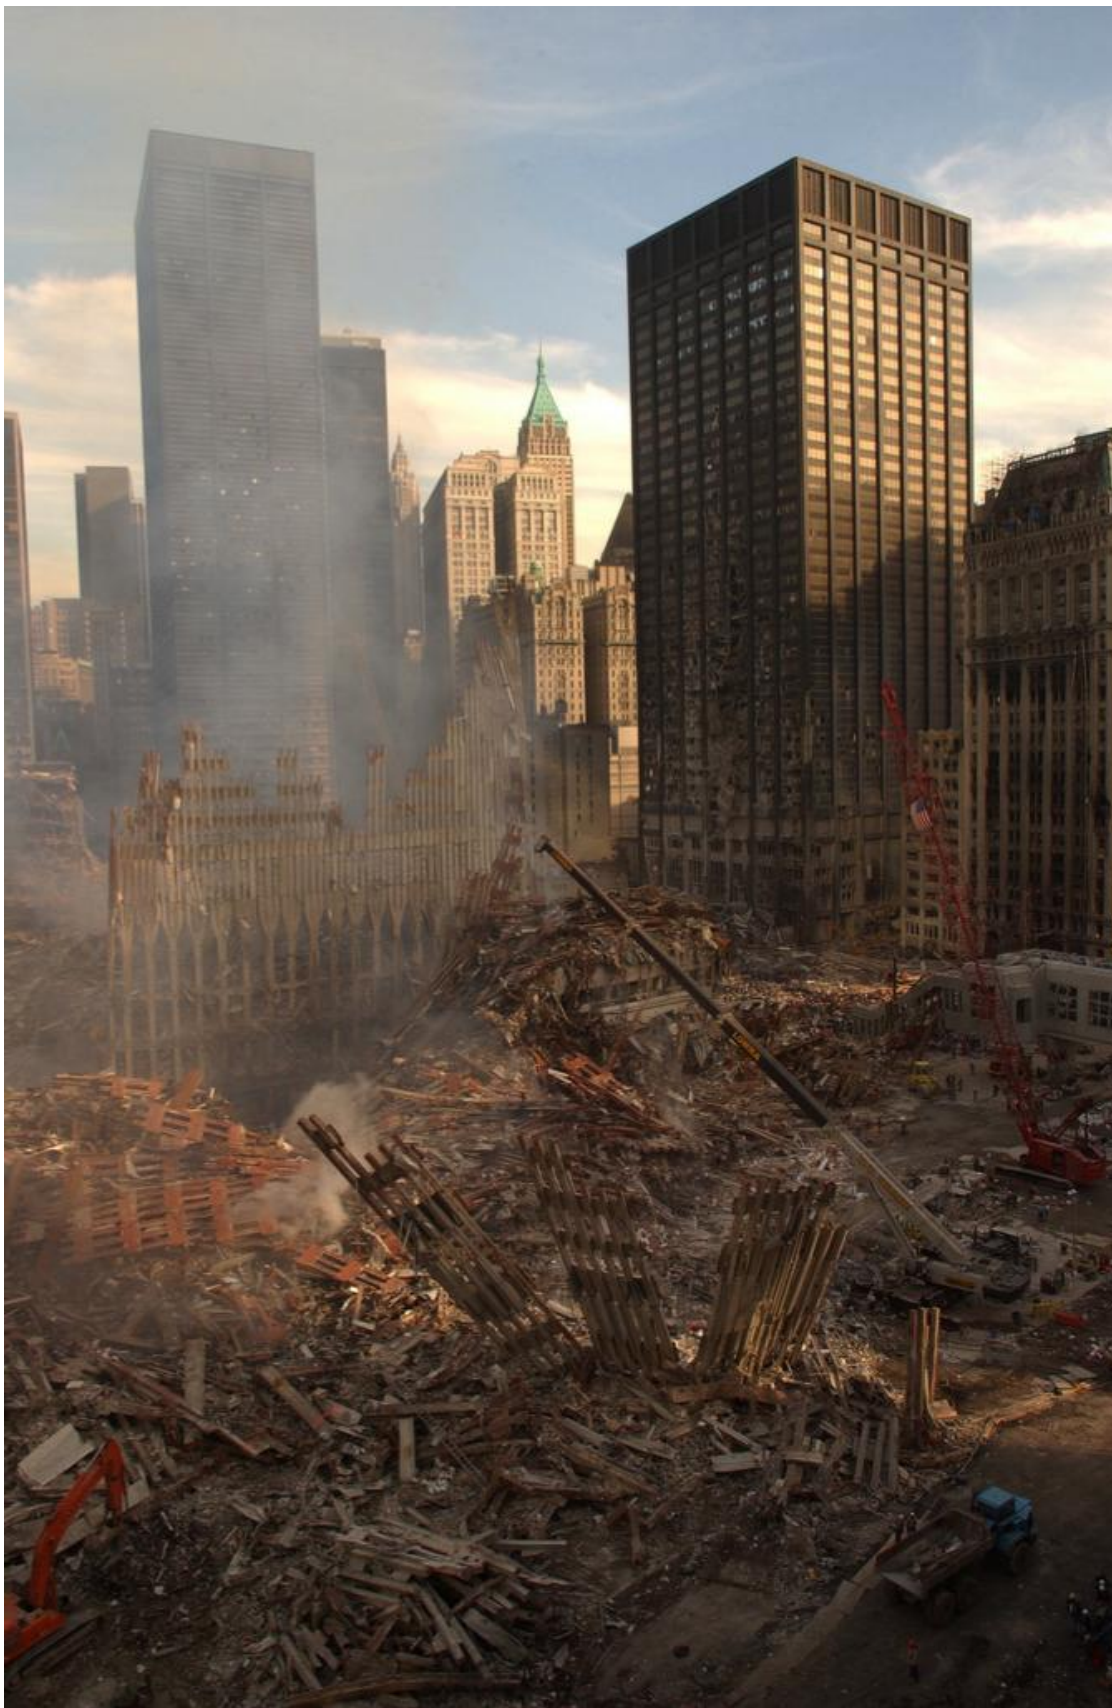
Figure 19. The three steel wheatchex stabbed into West Street in the foreground and the remains of WTC3 in the background, in front of the west wall of WTC2.

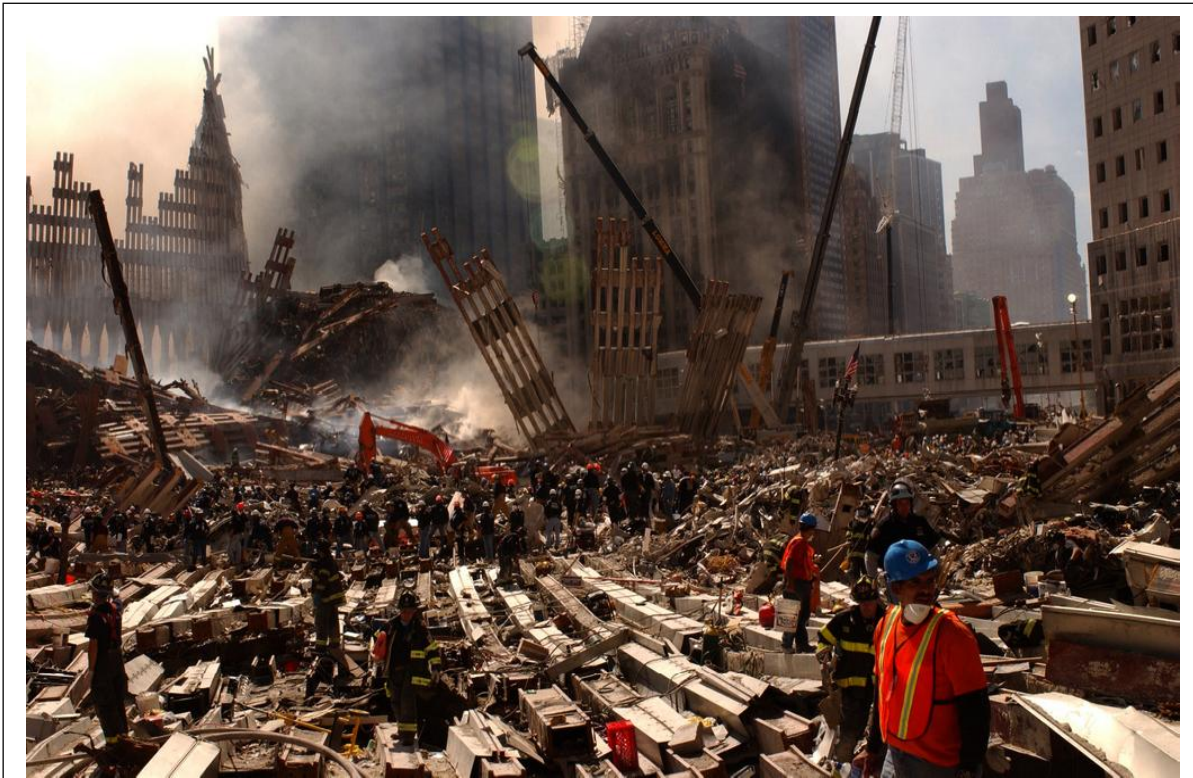
Figure 20. The remarkable "lay down" of steel wheightex from the lower stories of WTC1 on West Street (West Side Highway). The WTC3 debris pile is in the background, next to the unsupported WTC2 wall. (9/13/01)

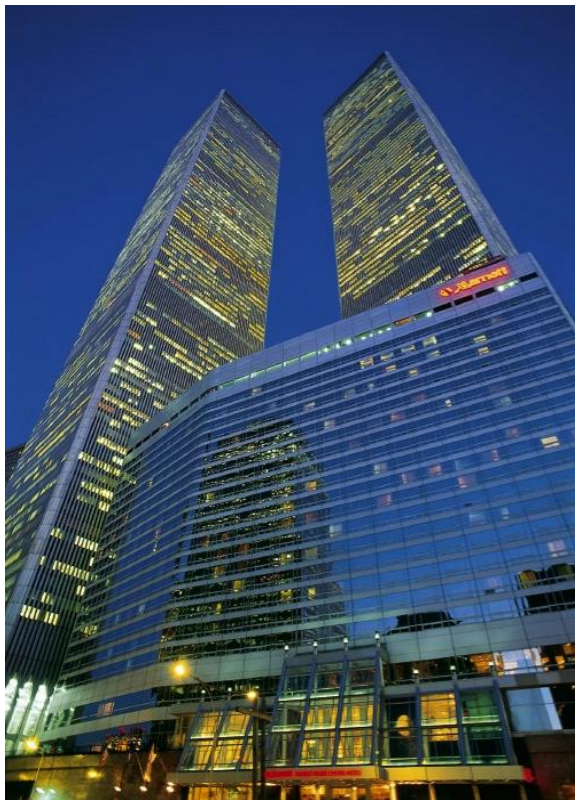
Figure 21. Here is a reminder of the material that must be accounted for in the rubble pile. Viewed from West Street.
